# **Debris/Ice/TPS Assessment And Photographic Analysis For Shuttle Mission STS-42**

March 1992

DEBRIS/ICE/TPS ASSESSMENT  
AND  
PHOTOGRAPHIC ANALYSIS  
OF  
SHUTTLE MISSION STS-42

January 22, 1992

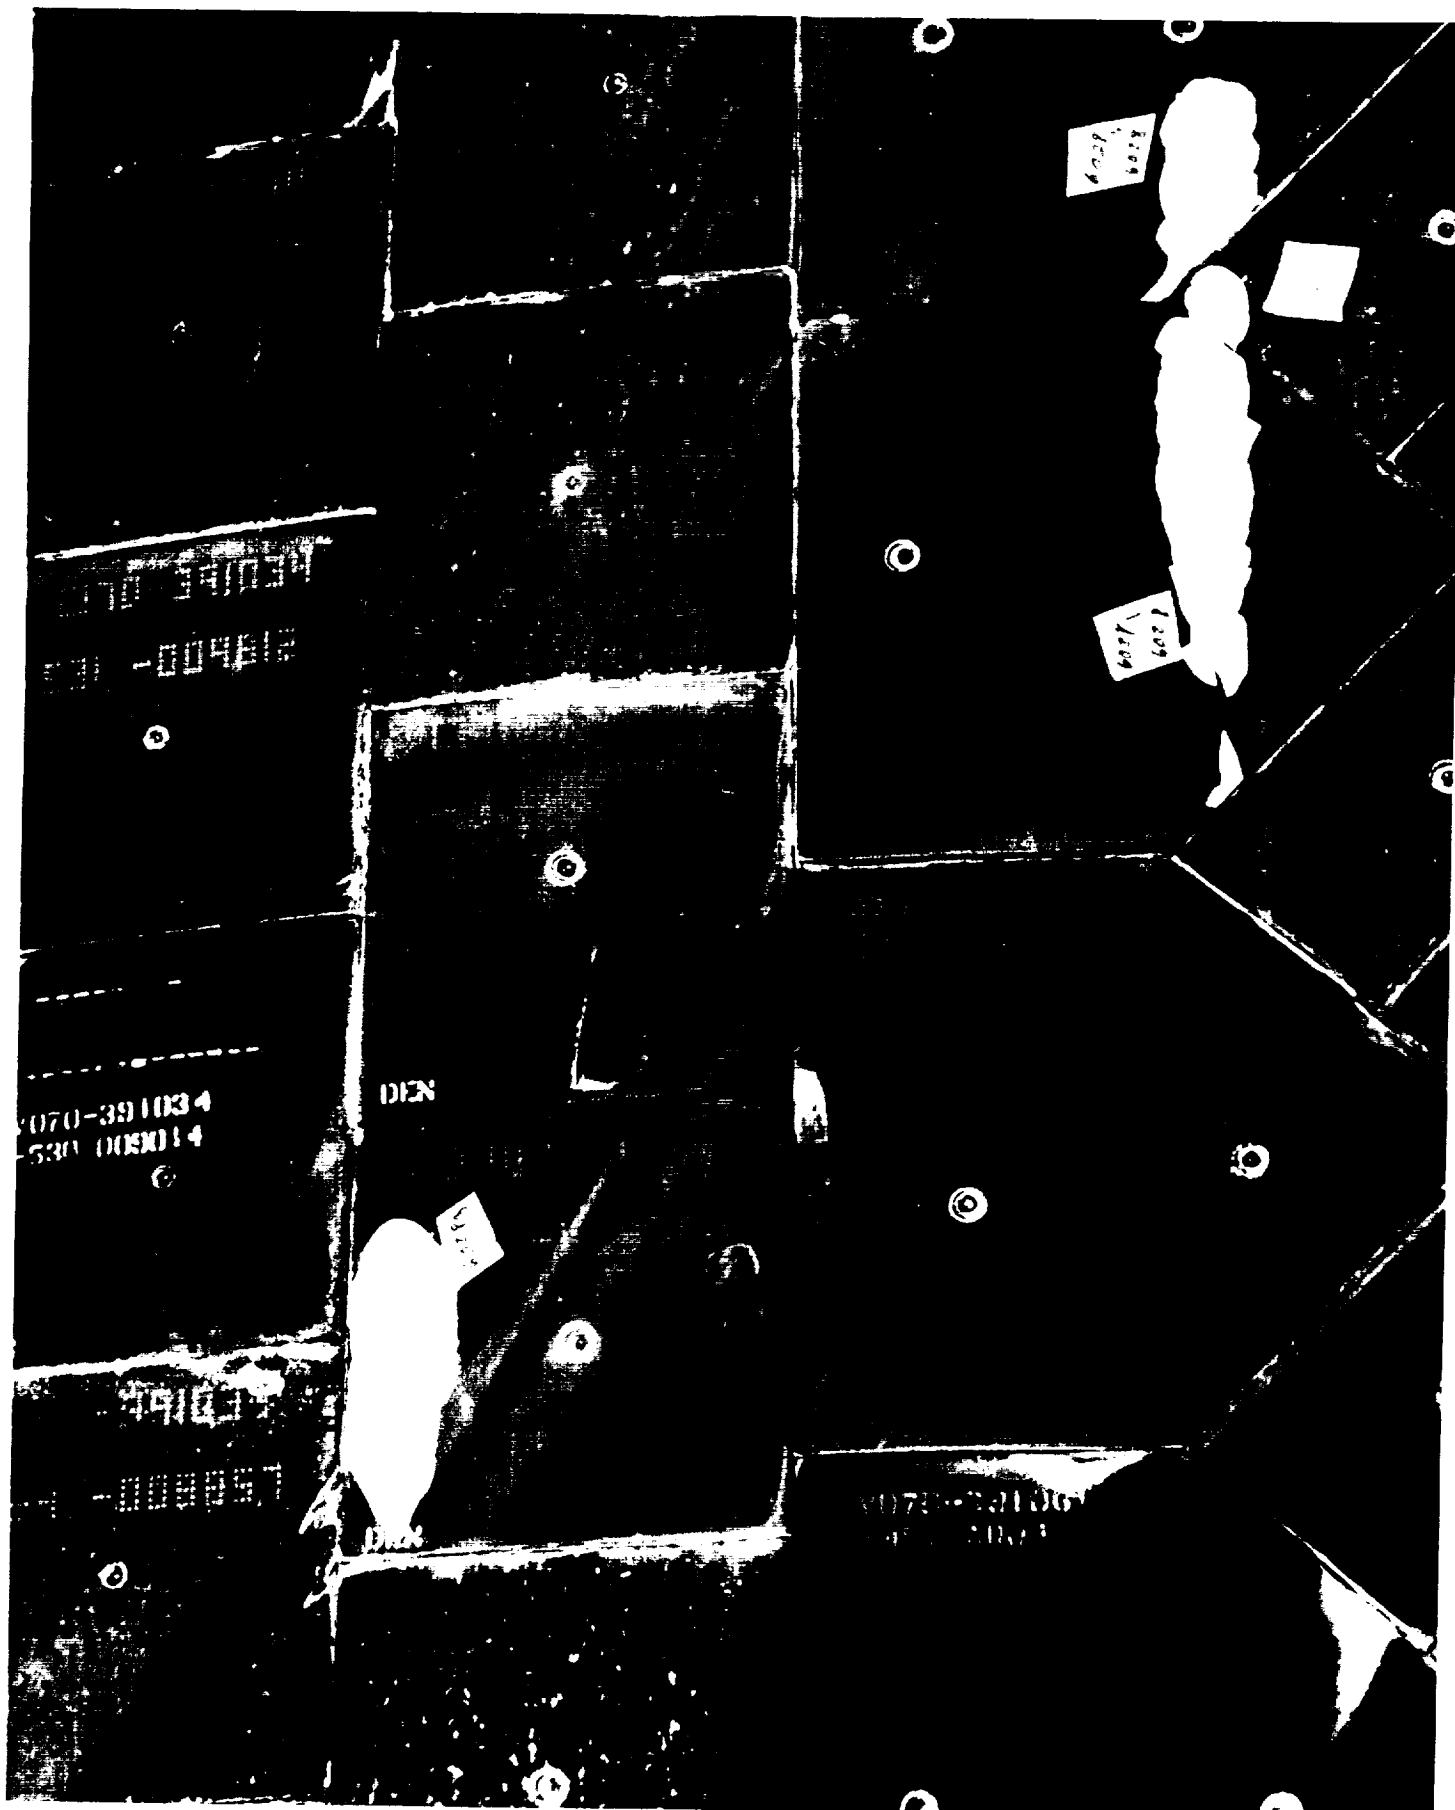
The largest tile damage site (10-3/4" x 1-3/8" x 1/4") occurred on the forward right hand side of the Orbiter lower surface

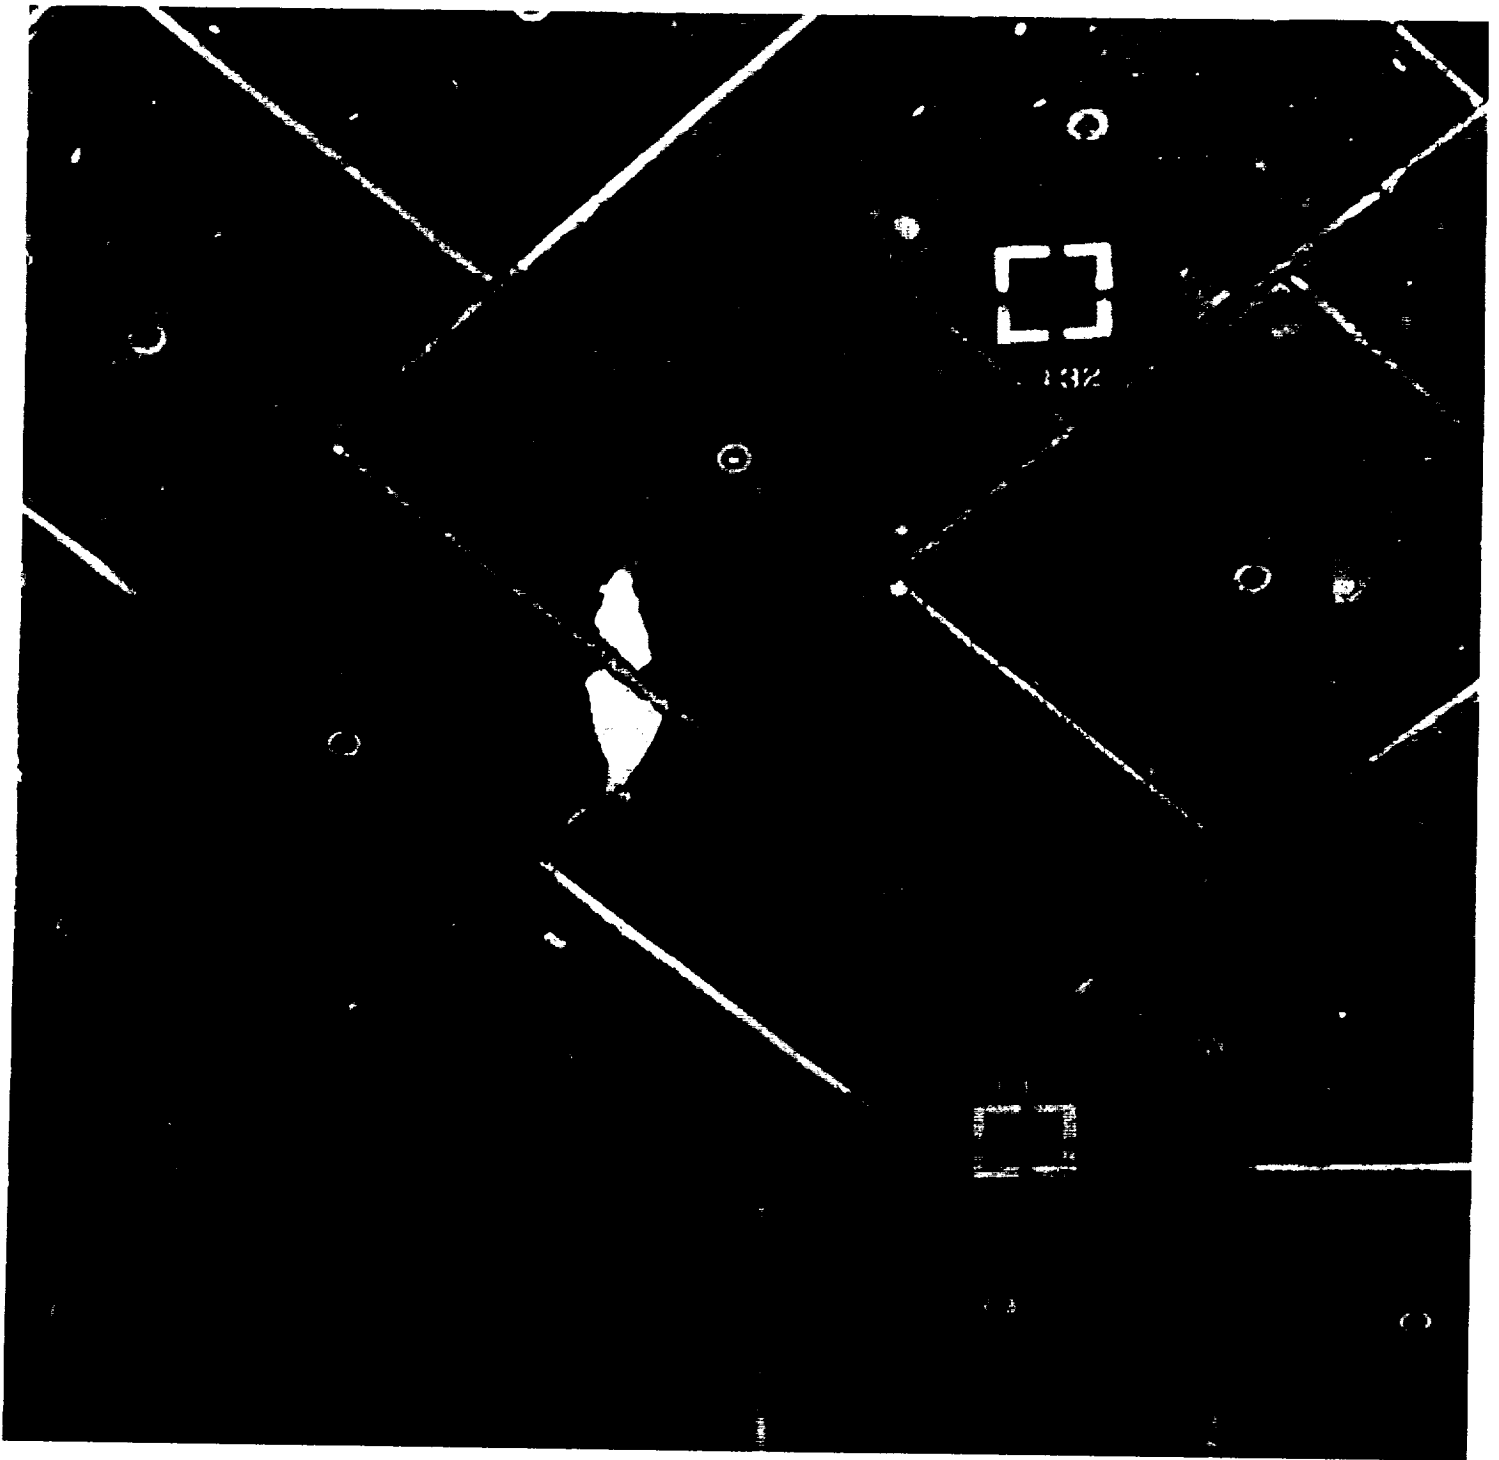
Typical tile damage on the Orbiter aft lower surface exhibited minor thermal erosion.

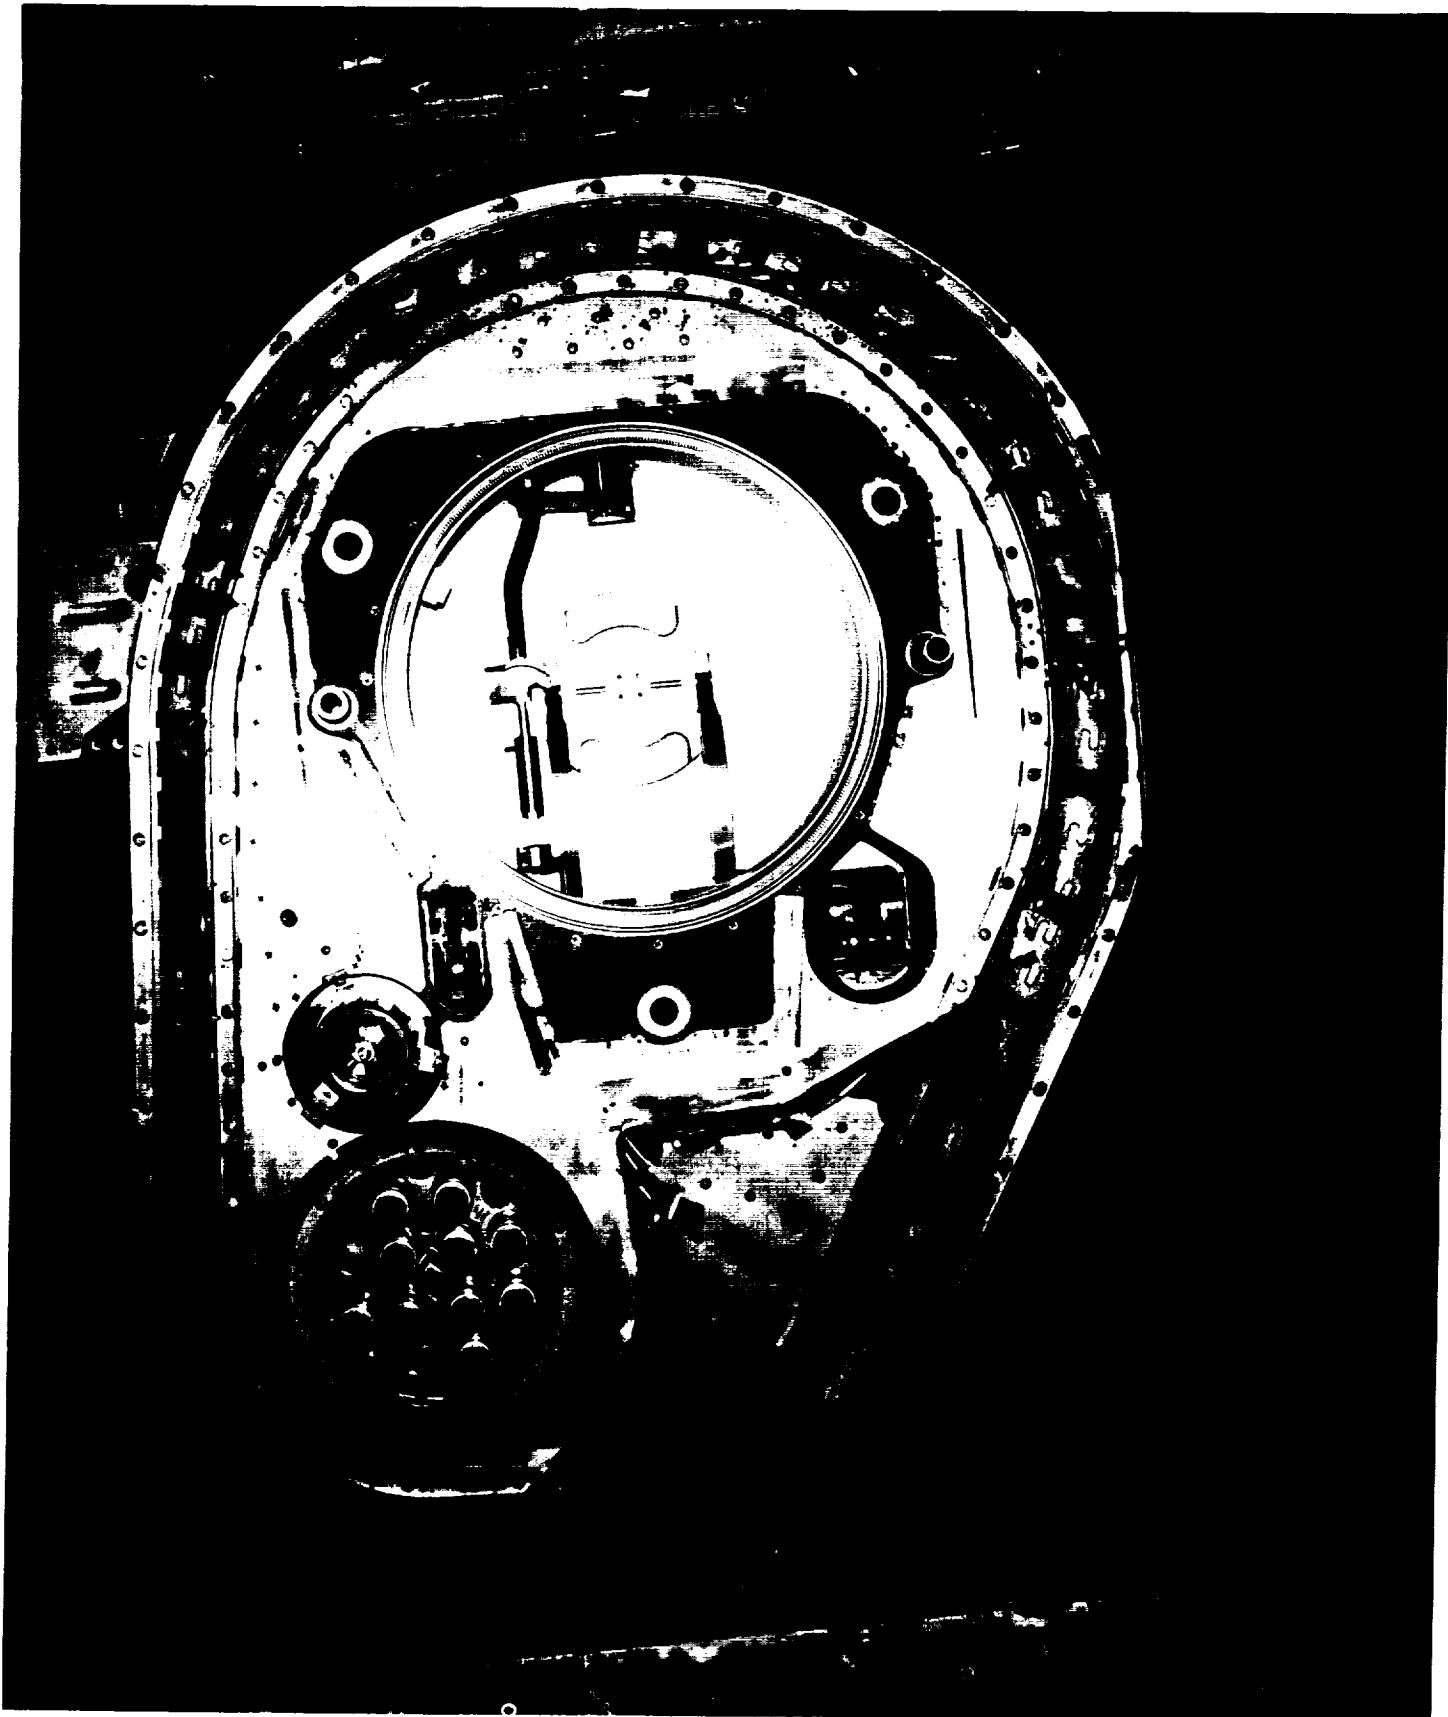
Overall view of the L02 ET/ORB umbilical. The separation ordnance device debris plunger in E0-3 was seated and appeared to have functioned properly. Wrinkling of the interface plate, particularly near the aft separation bolt hole, was attributed to shrinkage during cryogenic chilldown.

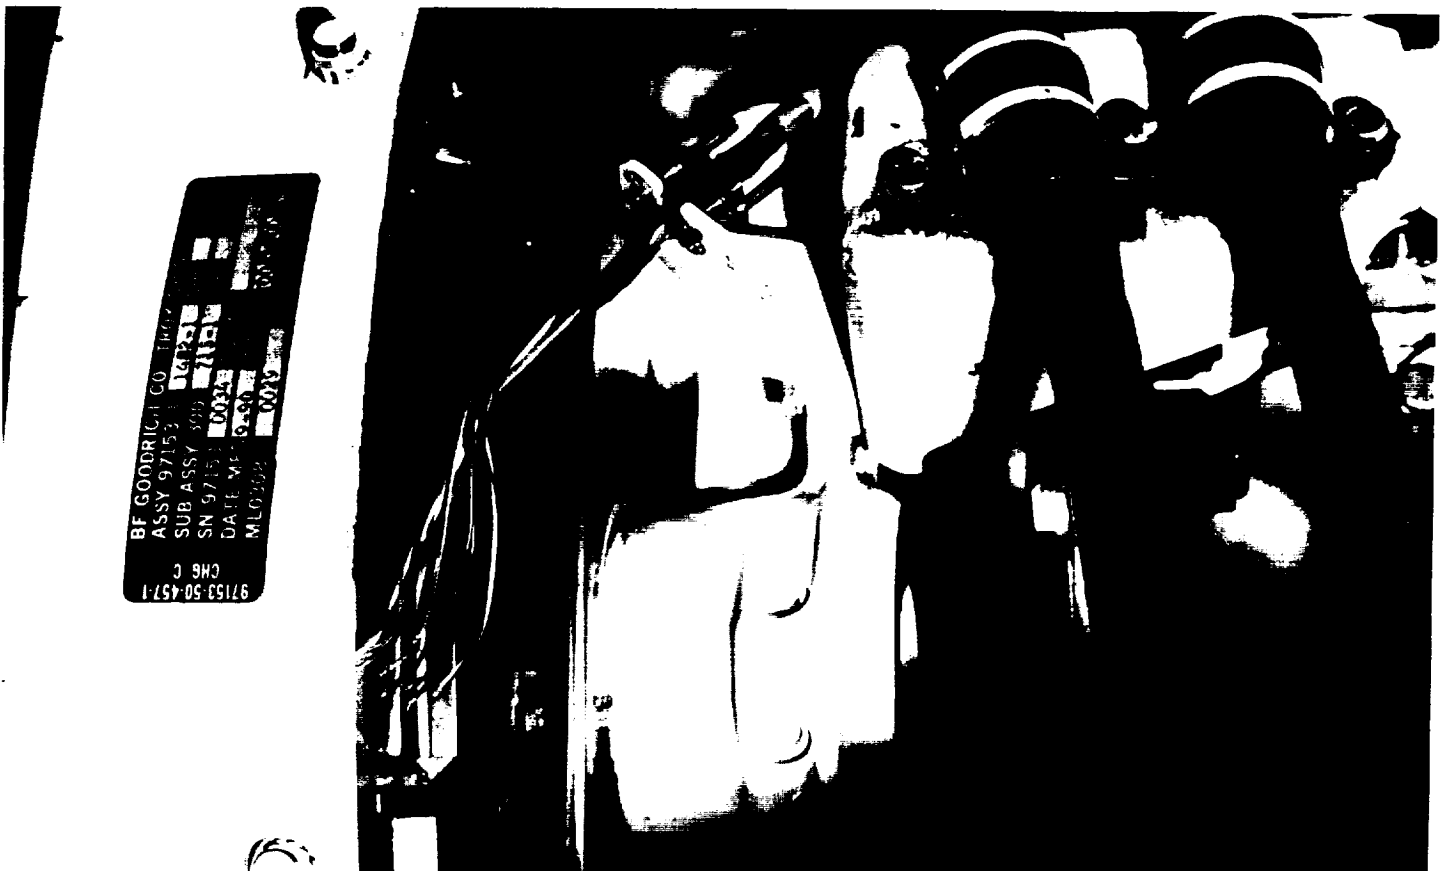
Comparative views showing small piece of RTV rubber material attached to strain gage wires (nominal configuration) and missing RTV from wires on the LH inboard main landing gear.
